CHIPPEWA CREEK EROSION CONTROL STUDY AND INVENTORY

**NORTH BAY-MATTAWA
CONSERVATION AUTHORITY**

**November 28, 2014
(Rev'd Feb. 18, 2015)**

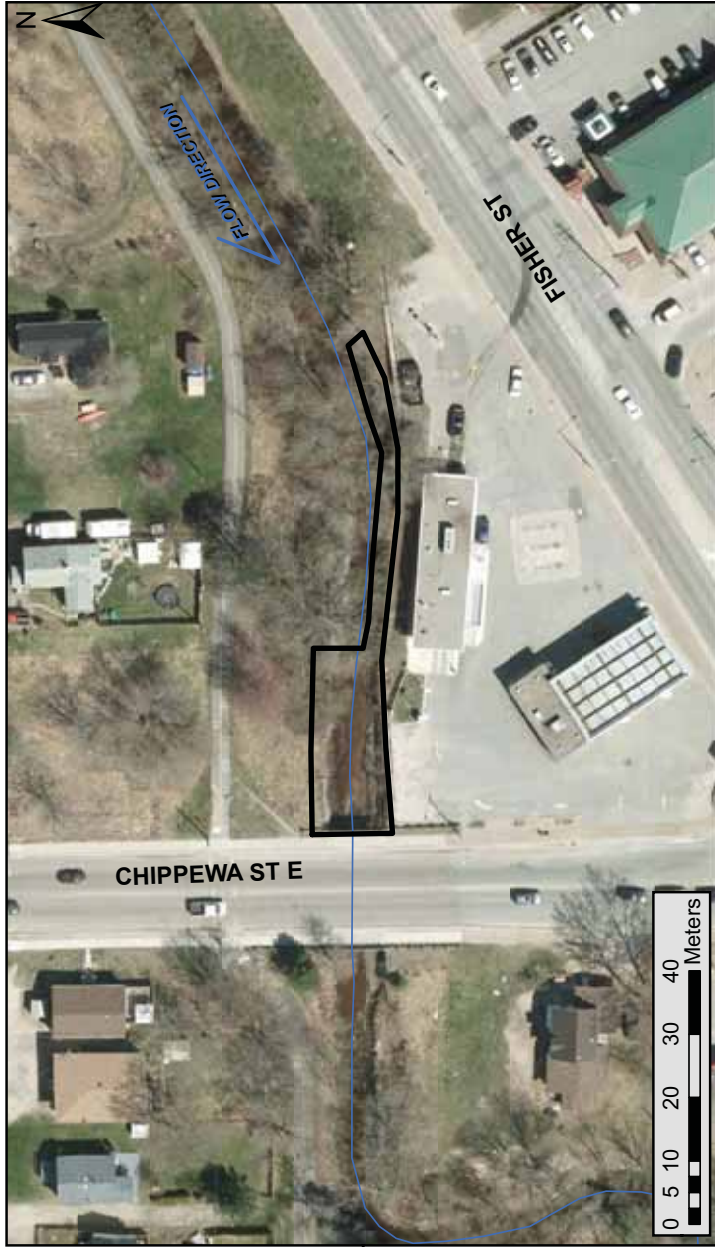
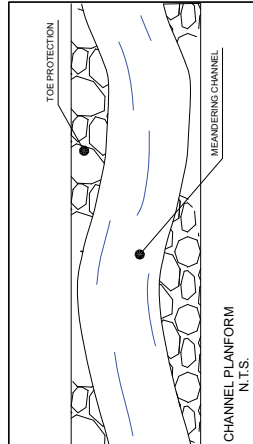
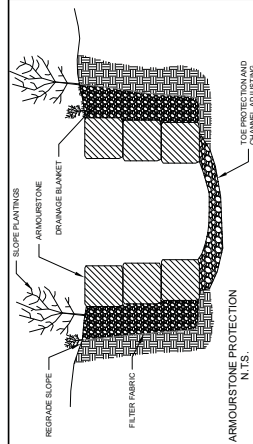
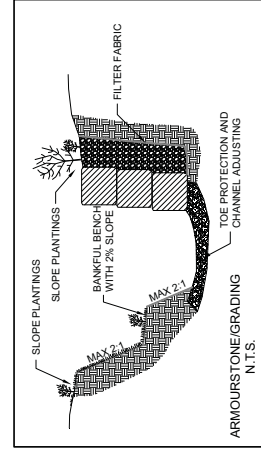
PROJECT FILE NO. 14040
SHEET NO. 2

The site is immediately upstream of Chippewa Street East and around the first bend on the left bank. Located behind the Shell Gas Station at Chippewa St and Fisher St. Kinsmen Trail runs along the right bank, with a setback of approximately 15m. Access can be made along the Kinsmen Trail.

Remove gabion baskets and other slope retaining features behind Shell Station and install a block armourstone wall with plantings. The slope of the armourstone wall may be less steep where setbacks permit. Remove gabions along right bank and regrade slope. Apply a bioengineering treatment such as vegetated rip rap up to the bankfull slope and perhaps the entire slope within closer proximity to the crossing (5m upstream). If possible create floodplain bench, otherwise try to create a 3:1 slope up to the trail.

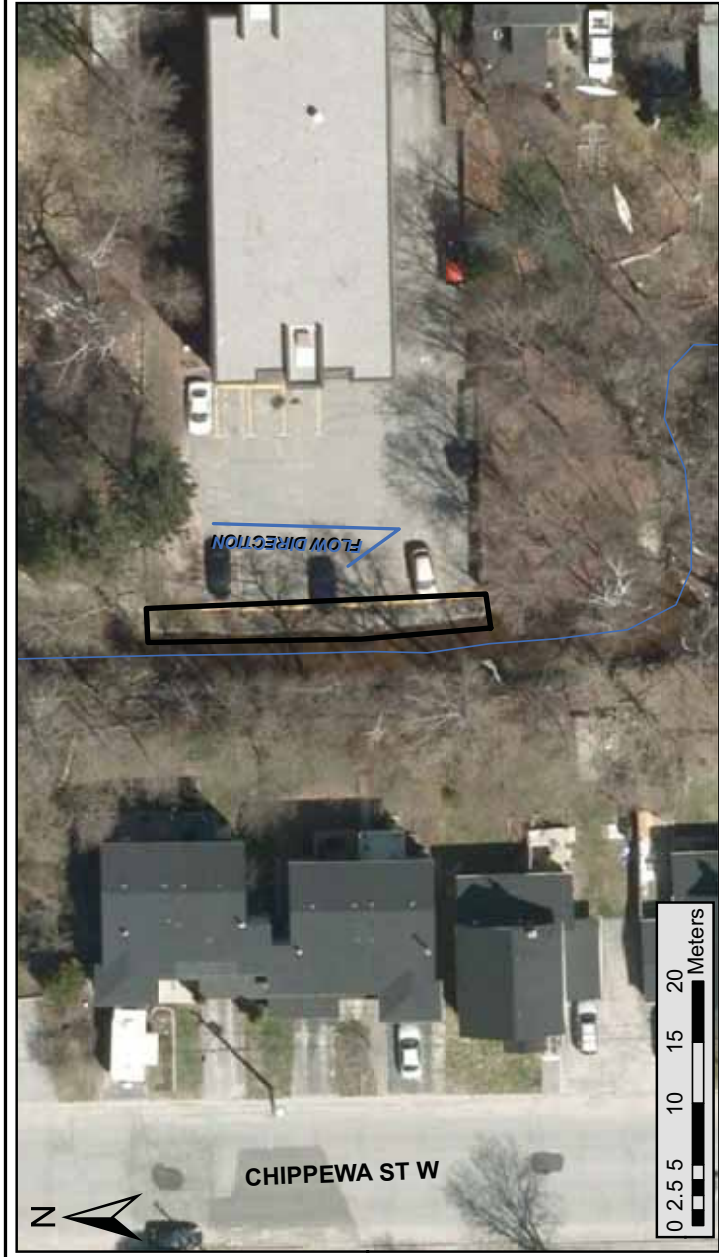
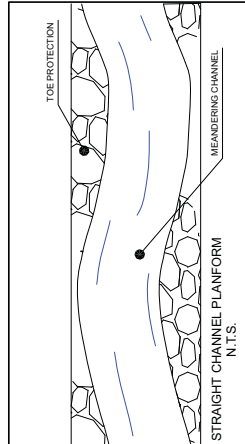
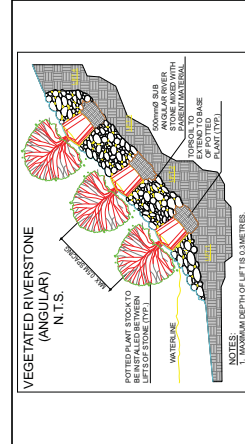
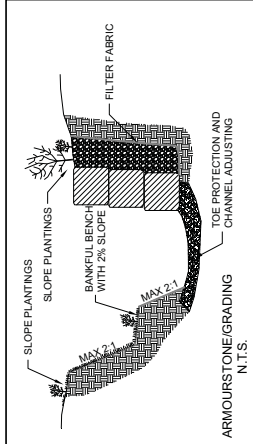
PROJECT FILE NO. 14040
SHEET NO. 6

The site is along the right bank of Chippewa Creek located behind an apartment building at 365 Aubrey St. Access could be made through the building parking lot.

Remove cemented stone structure and replace with armourstone wall with plantings.
Realign channel upstream to better align with structure, or extend treatment upstream.
Regrade opposite bank or develop floodplain bench and apply vegetated rip rap.

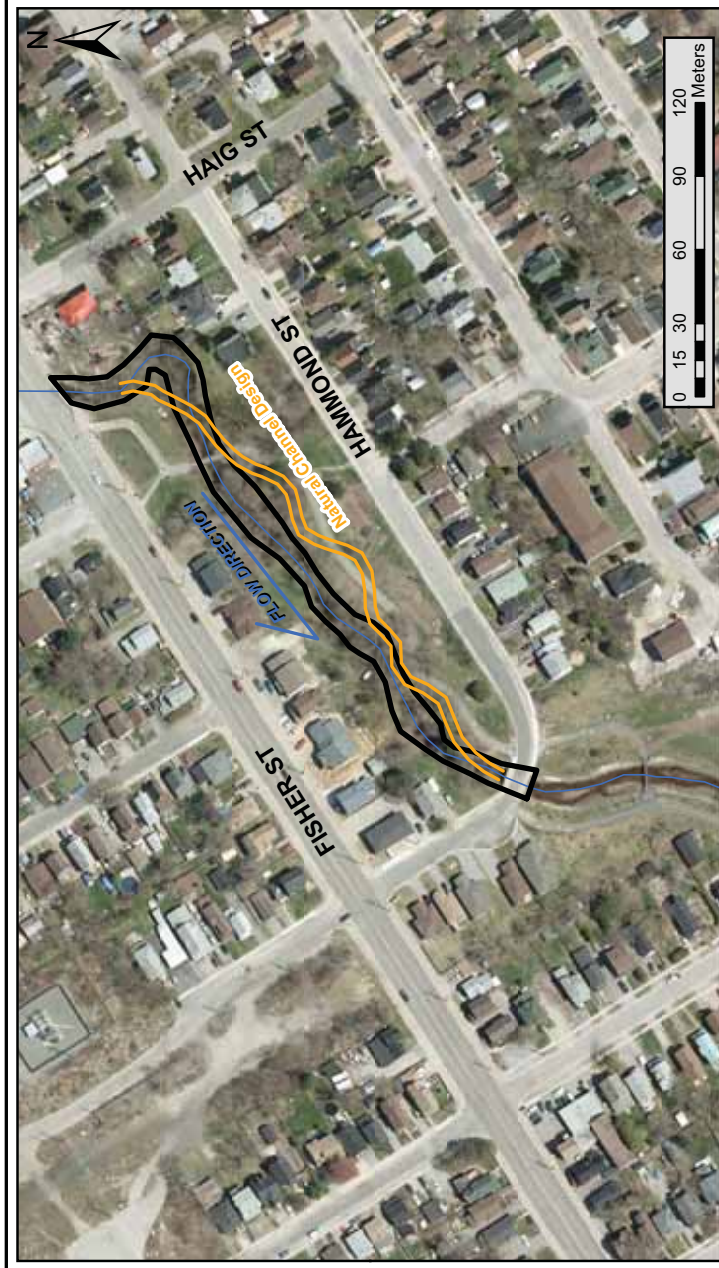
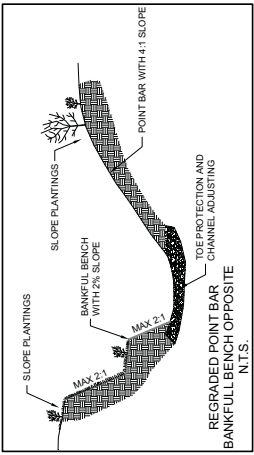
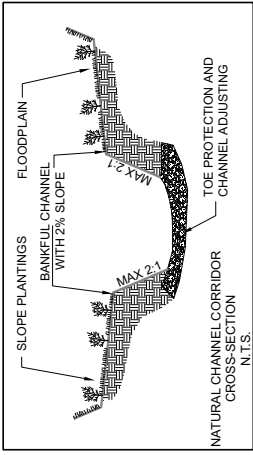
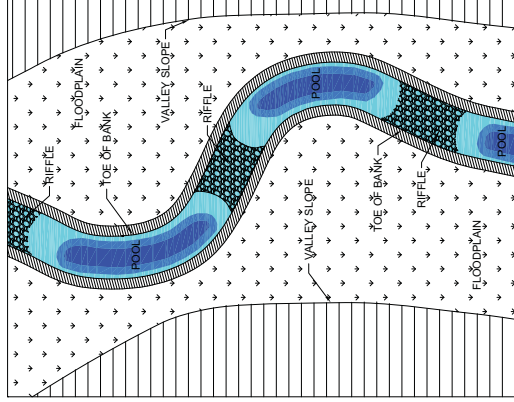
Chippewa Creek	Erosion Control Study and Inventory
Priority Sites	#7 - CA14 (Reach CC-4)
PROJECT FILE NO. 14040	SHEET NO. 7

The site is on Chippewa Creek between Hammond Street and Fisher Street, and runs through Fisher Street Park. This site consists of eroding banks, falling retaining wall, fence falling into creek, and vertical boulder wall. Along the left bank, there is the Kinsmen trail and what appears to be empty park space between the trail and Hammond St.

The Kinsmen trail appears to follow a park corridor consisting of open space. This provides the opportunity to realign the channel away from private properties and develop a more sinuous and natural planform with a floodplain. Upstream of the pedestrian bridge, relocate the channel bend towards the west, and downstream of the pedestrian bridge, relocate the path and the channel away from private property. If that is not possible, a pool riffle sequence should be developed with bioengineering techniques. Regrade the inner bank of meander bends and create a floodplain area. Replace Hammond Street bridge with wider structure.

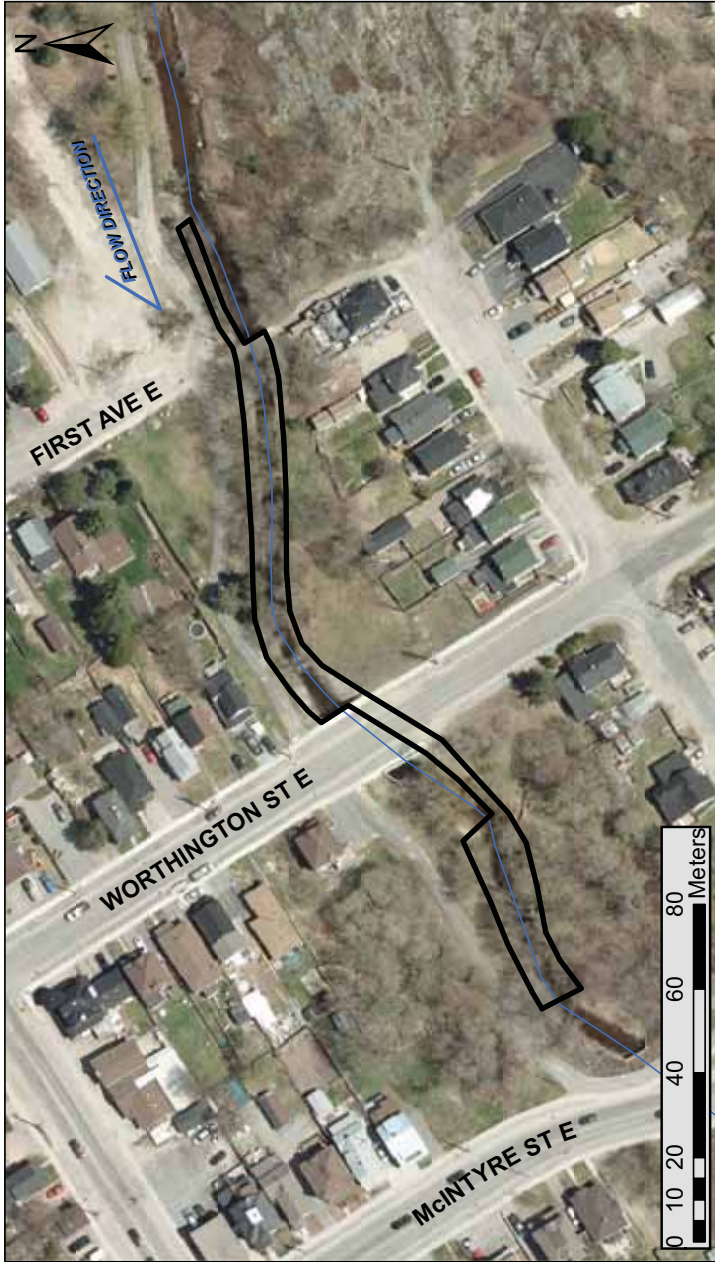
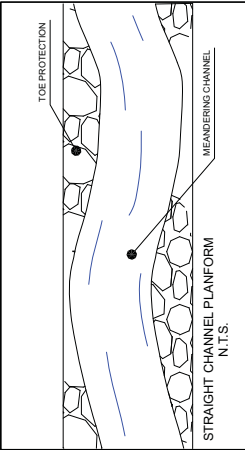
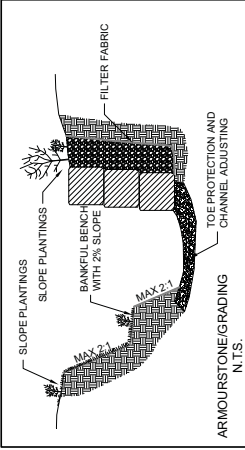
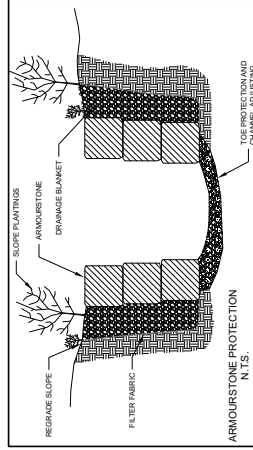
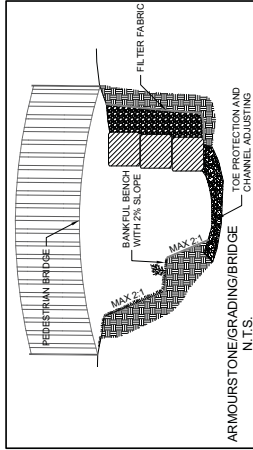
PROJECT FILE NO. 14040
SHEET NO. 8

The site is located on Chippewa Creek upstream of McIntyre Street E to just upstream of the pedestrian bridge at the end of First Ave E. Residential properties follow both banks throughout. The Kinsmen Trail follows the Right bank, and is within 3m of the creek. Some open space and woodlots are visible from air photos.

Banks should be regraded where possible and a floodplain developed. Bioengineering techniques such as vegetated rip rap can be used for the bankfull channel. Plantings in the floodplain. Vertical armourstone will likely need to be applied along portions of the trail and on the upstream and downstream sides of Worthington Street. The pedestrian bridge at the end of First Ave should be upgraded, with 2:1 banks underneath instead of the exposed footings and piled concrete sidewalk slabs. Vernal pools (depressions) in floodplain areas can add some storage and habitat.

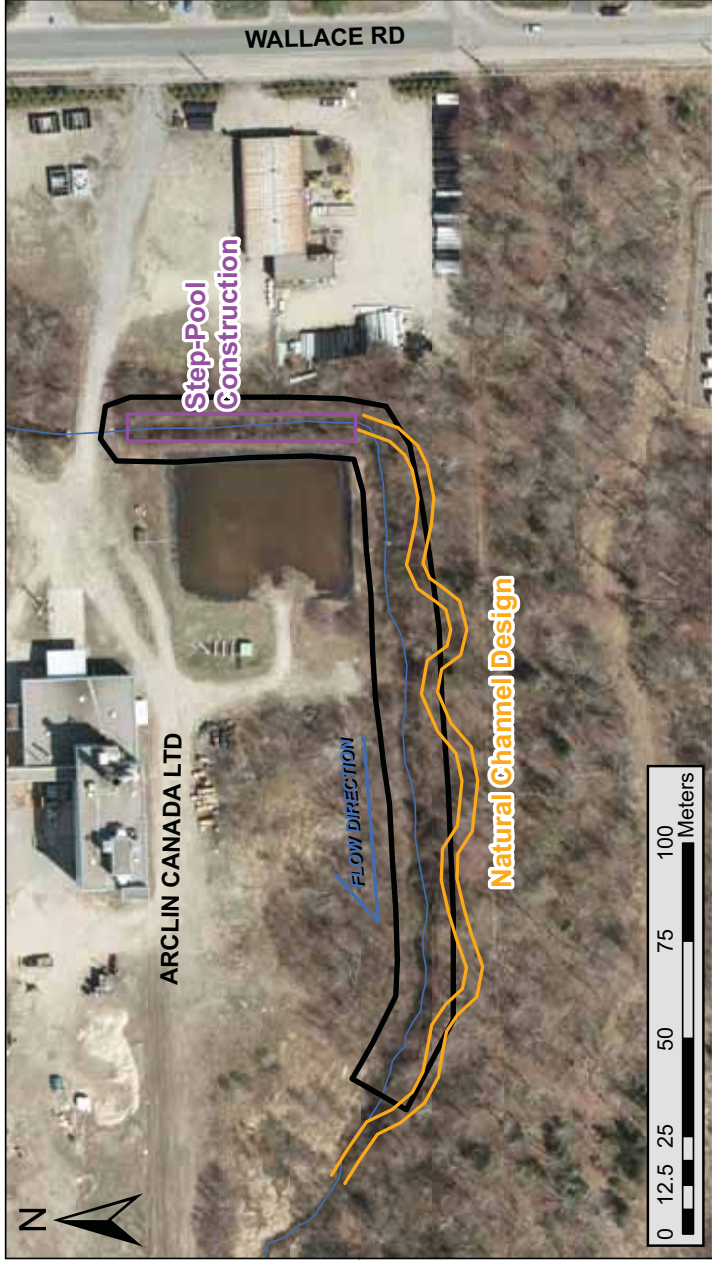
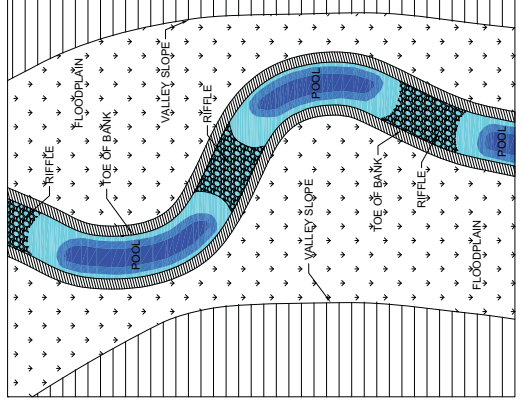
1. SITE LOCATION/DESCRIPTION
 The site is located along Johnstons Creek within the industrial plant (Arclin) property. This section is relatively straight, steep and confined. Sand and silt banks are eroding, and wood debris occurs throughout. Exposures of glacial fill occur at some locations.

2. PROBLEM DESCRIPTION
 Historical watercourse lines indicate that this portion has been relocated and channelized around a water quality pond along the southern boundary of the property. As a result of this channelization, the channel has become increasingly entrenched with failing sand banks and woody debris throughout.

4. RECOMMENDATIONS
 In order to address this site sooner than later, it is assumed that realignment through portions of the industrial site cannot be achieved. Upstream and around the 90 degree bend, a step pool sequence can help reduce the slope. Downstream of this bend, the channel should be relocated away and a new corridor with floodplain created, including a sinuous channel and appropriate plantings. If a corridor is developed, robust bank treatments will not be required and the channel should be allowed to adjust over time.

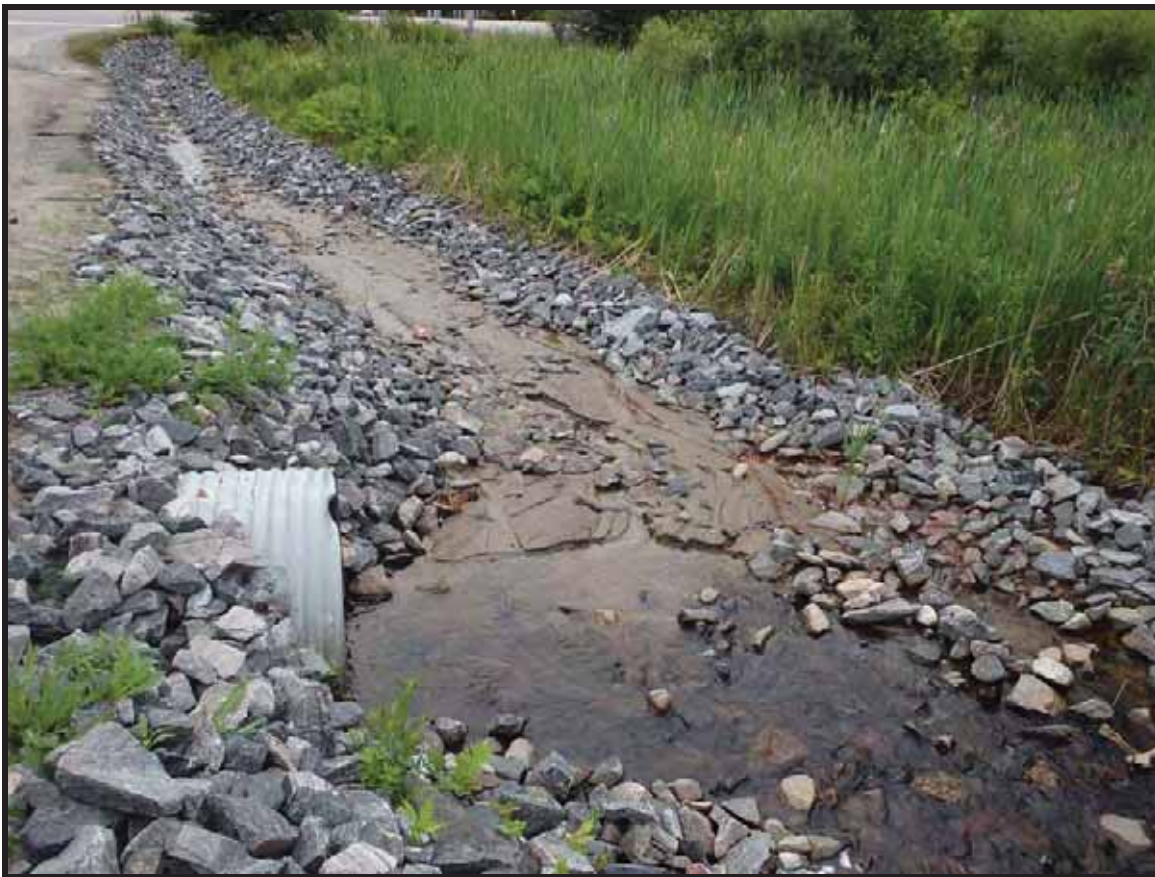
9. Staff observed sediment-laden road runoff being discharged to the creek at Marsh Drive (north side of the road) while the creek flow itself was entirely clear of sediment (see **Photograph 1**).

Photograph 1 Sediment movement into Chippewa Creek upstream of Marsh Drive

Based on field observations, staff believe that road sand applications during winter periods is a large contributor to the sediment accumulation in lower reaches. NBMCA should gain access to road sand application rates within the City of North Bay in order to verify this assumption.
