CHIPPEWA CREEK EROSION CONTROL STUDY AND INVENTORY

**NORTH BAY-MATTAWA
CONSERVATION AUTHORITY**

**November 28, 2014
(Rev'd Feb. 18, 2015)**

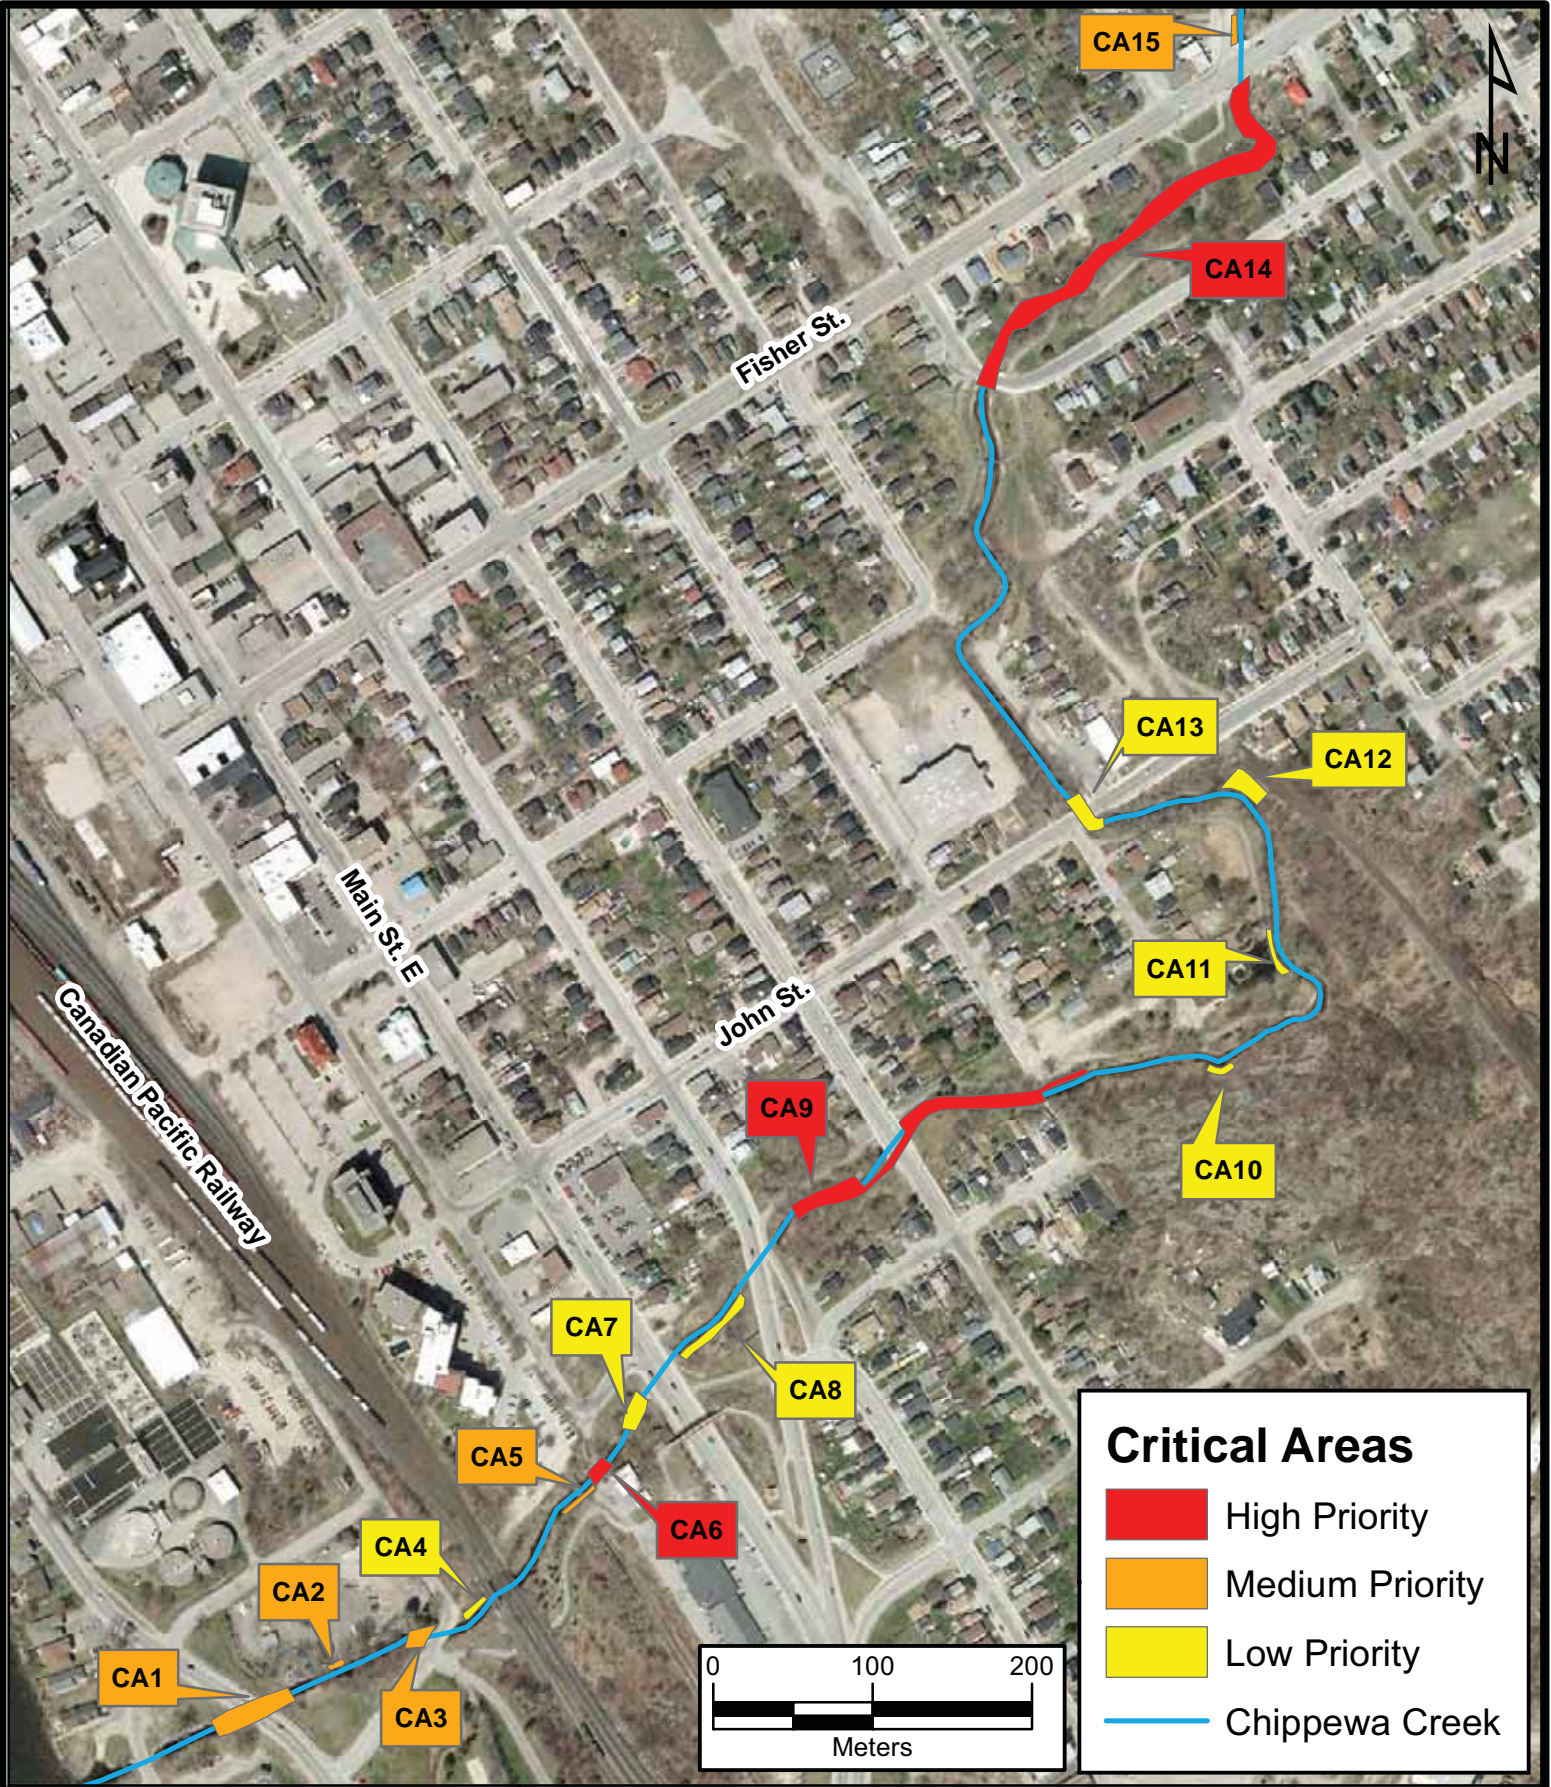
Figure No.:
 3.3
 Checked By:
 EG/JM

Three exposed pipes were discovered along two reaches (CC-9a and CC-10) (**Figure 3.13**). Appropriate costs are allotted to each exposed pipe. Critical Area 28, a high priority site, has an exposed pipe within its area. The other exposed pipes are located in Critical Area 41 and 42, and Critical Area 24 (**Figures 3.4 and 3.6**).

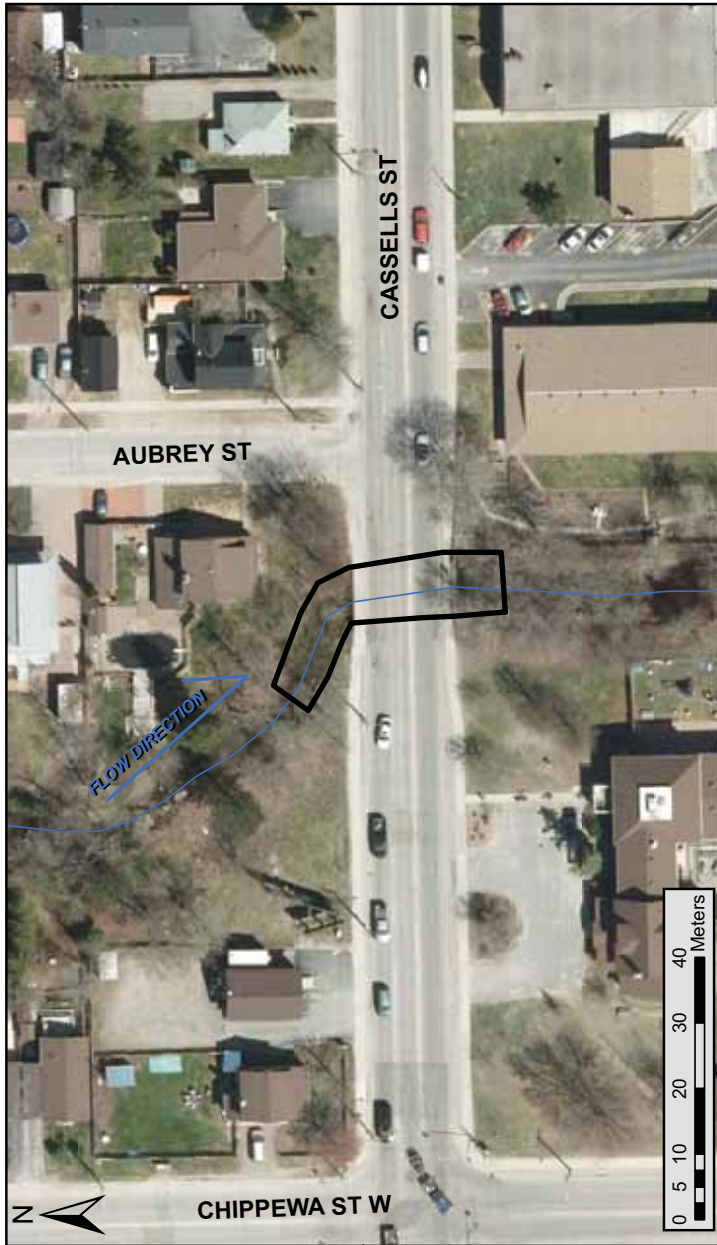
Chippewa Creek	
Erosion Control Study and Inventory	
Priority Sites	
#1 - CA6 (Reach CC-2a)	
PROJECT FILE NO. 14040	SHEET NO. 1

1. SITE LOCATION/DESCRIPTION

The area includes Cassells Street bridge and immediately upstream and downstream of the bridge.
Site access would be Cassells Street.

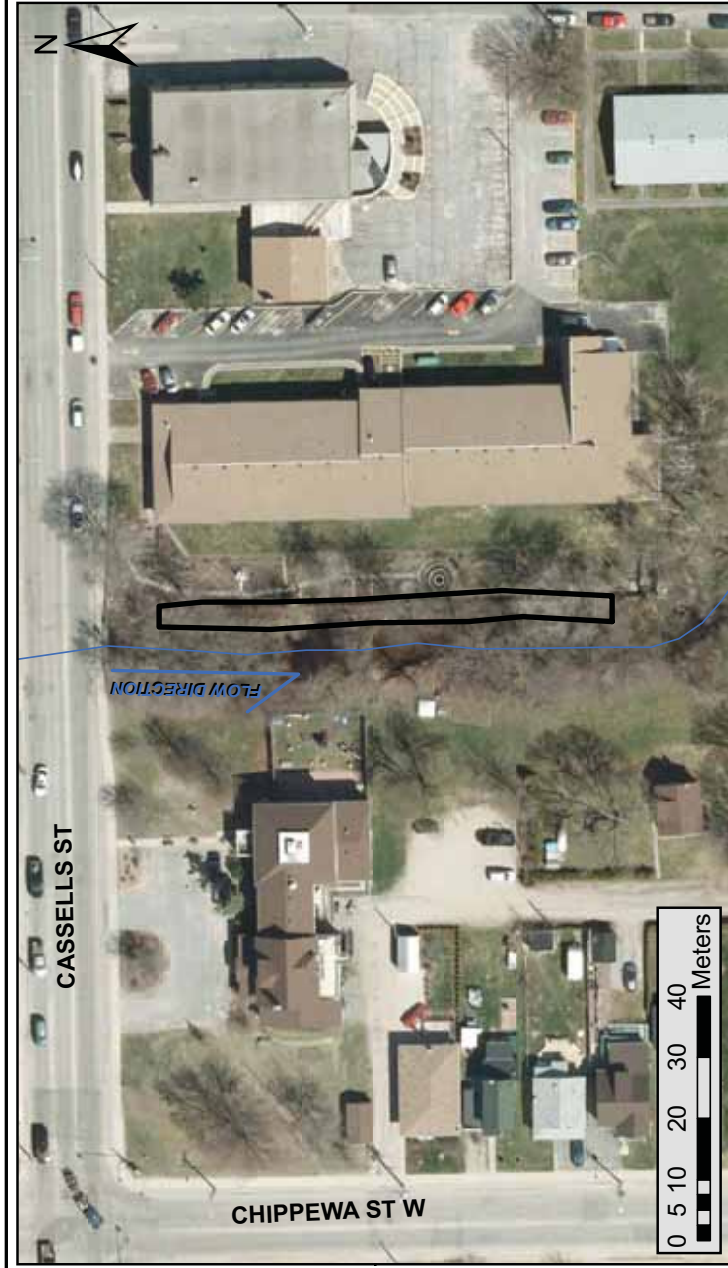
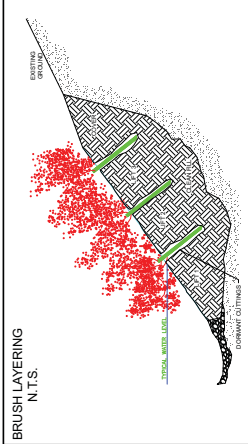
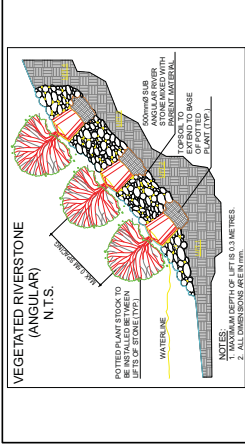
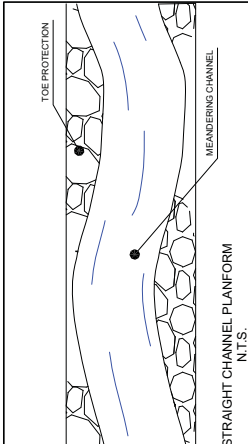
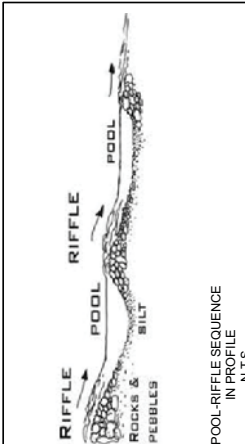
Chippewa Creek
Erosion Control Study and Inventory
Priority Sites
#4 - CA16 (Reach CC-5)
PROJECT FILE NO. 14040
SHEET NO. 4

The site is immediately downstream of Cascells Street. Private property is located at the very top of and eroding left bank with a residential unit located approximately >15m from top of slope. Access could be made along the channel from Cascells or through private property.

Create pool-riffle sequence to transition from Cascells Street and downstream.
Acquire land along right bank in order to develop a floodplain bench and regrade the banks.
With setback being limited along right bank, create a vertical brush mattress wall or vegetated rip rap buttress to ensure that failure does not continue. Brush Layering may also be a possible treatment, but this can be determined during detailed design.

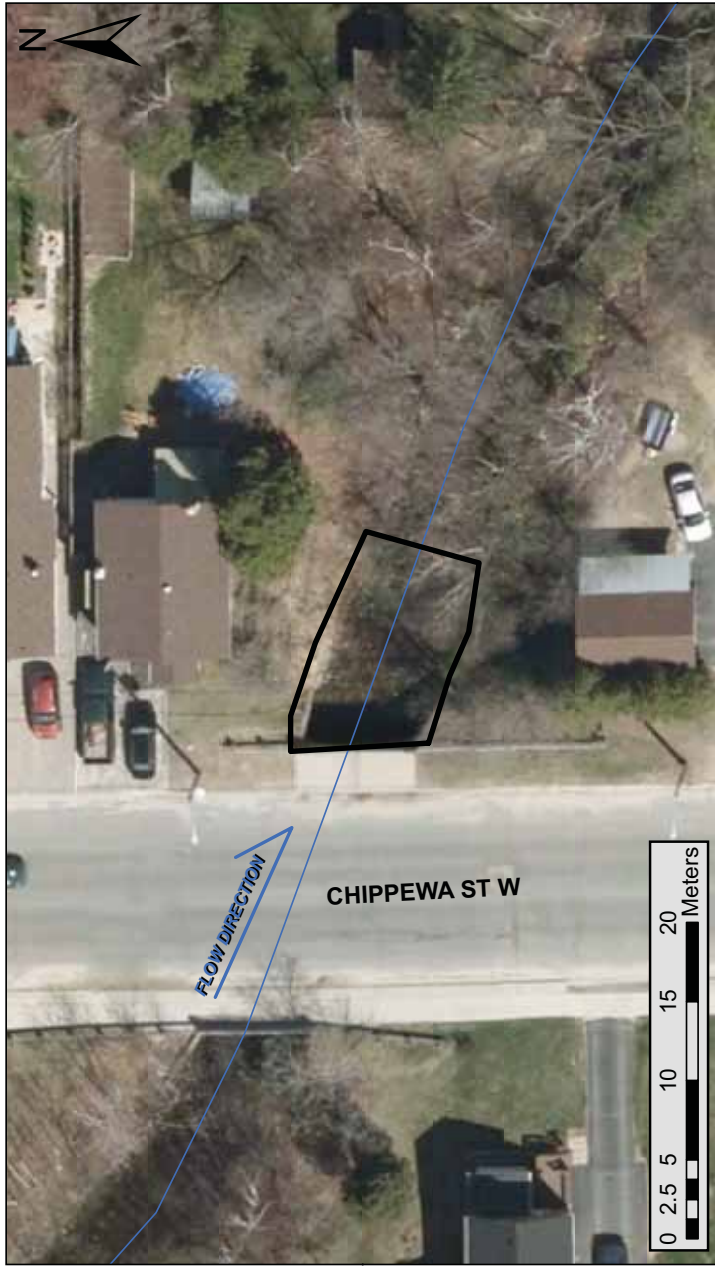
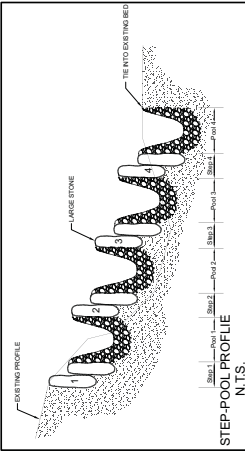
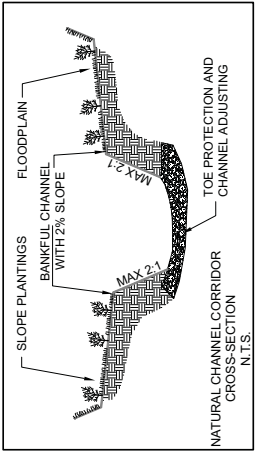
Chipewewa Creek
Erosion Control Study and Inventory
Priority Sites
#9 - CA71 (Reaches JC-7a and JC-7b)
PROJECT FILE NO. 14040
SHEET NO. 9

The site is immediately downstream of Chippewa St. W, south of the intersection with High St. The site can be accessed off of Chippewa St. W bridge.

The gabion baskets are slumping and failing. The bed is armoured between each bank.
